RICHMOND HOUSE, WORCESTER PARK, LONDON KT4

INITIAL REPORT ON CAUSES OF FIRE SPREAD

26 NOVEMBER 2019

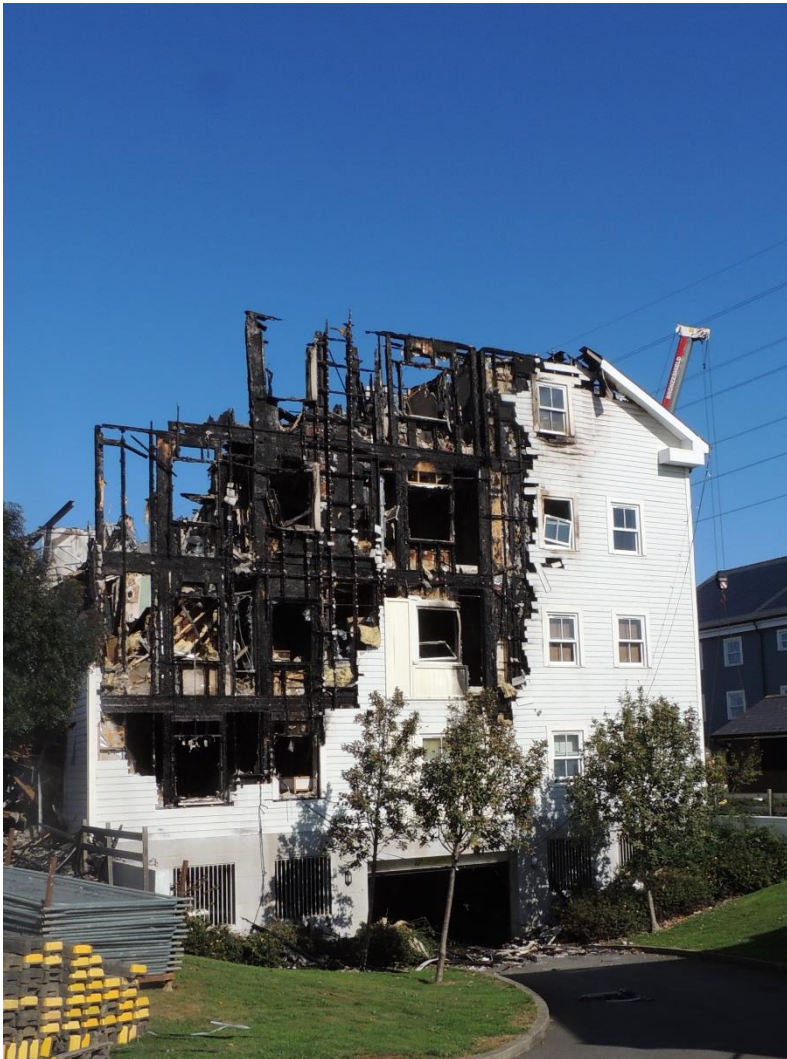
- 1.1 This report has been prepared following the fire at Richmond House early in the morning of Monday 9 September 2019. The fire spread rapidly and destroyed much of the block, despite the efforts of 125 firefighters. The photograph below shows the aftermath, with much of the south west elevation having been destroyed.

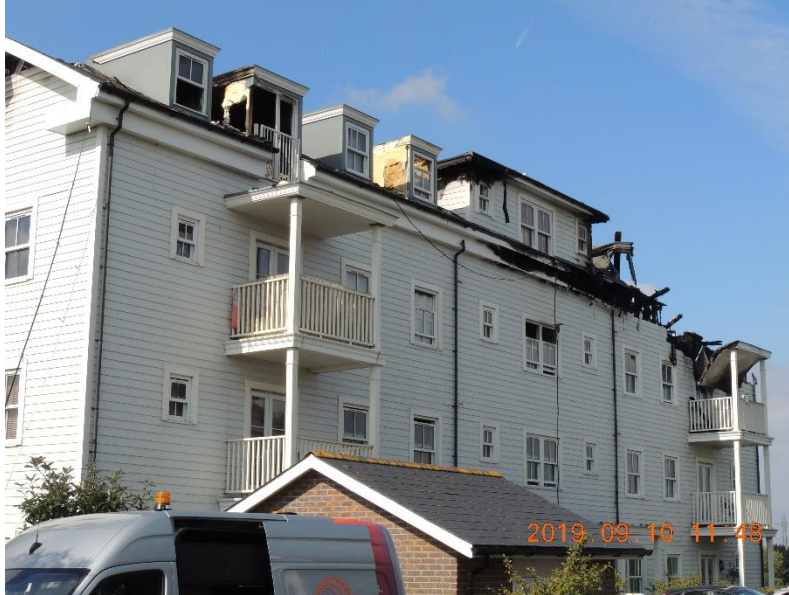
- 1.2 The fire did less damage on the north east elevation. The photograph below shows that elevation: there was very significant damage to the north west, while the walls and the roof to the south east remained largely in place.

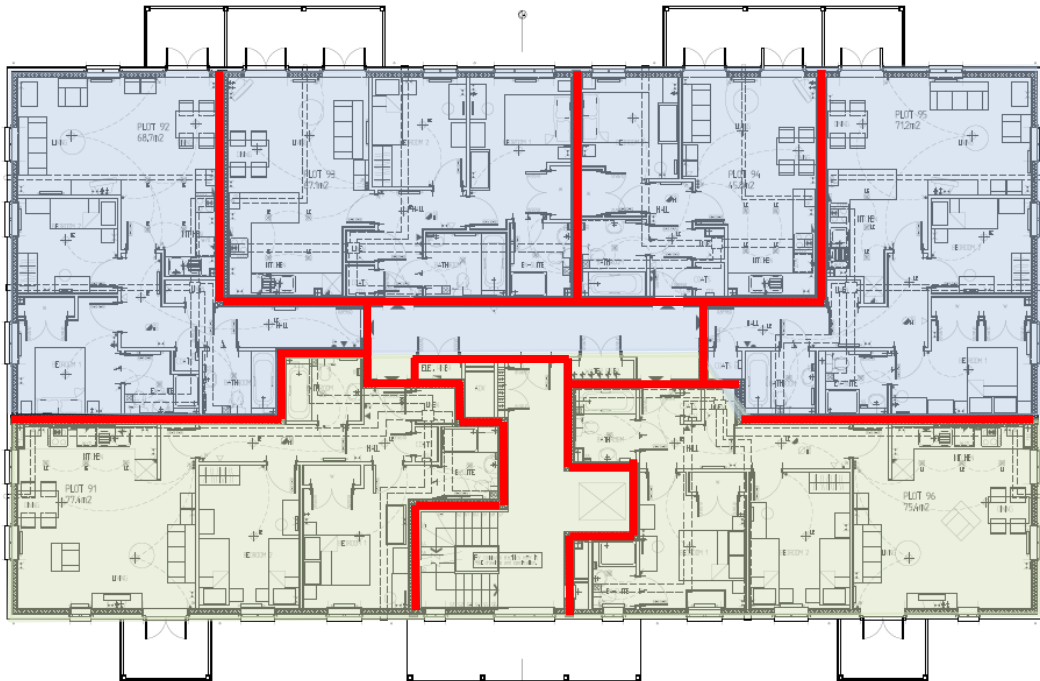
- 2.3 The plan below, shows the second floor layout of the building. The lines in red show the main lines of internal fire resistance, providing 60 minutes' fire resistance. The area above the line, shaded in blue, was largely destroyed; that below the line, shaded in green was remained largely intact, except at top floor and roof level where fire spread via the roof.

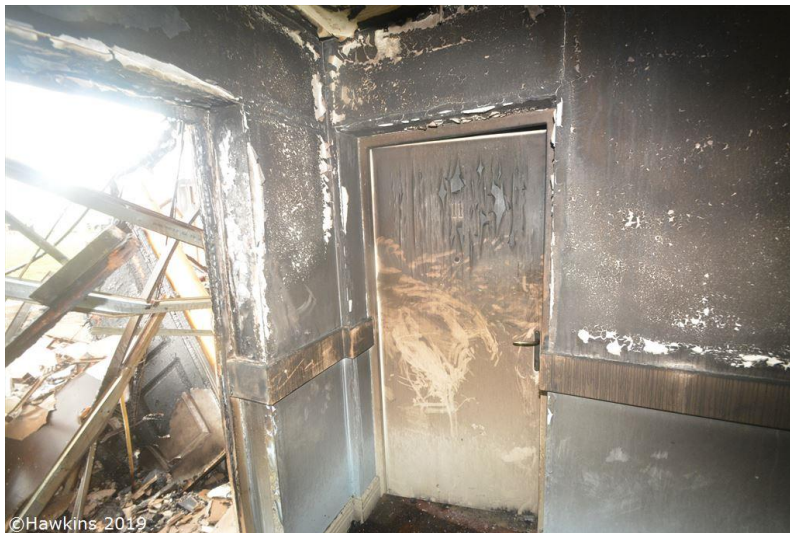
2.4 The internal walls and doors resisted the spread of fire more effectively than the external walls. While the flats to the south west of the circulation corridor were almost completely destroyed, those to the north east suffered little direct damage from the fire: they were damaged by smoke, and by firefighting water, and the structure as a whole became unstable, but the fire was held back on this line for a reasonable period of time.

2.5 The photograph above shows the condition of the wall in a flat on the "fire" side of the corridor. Through the doorway to the left, the flat has been completely destroyed by the fire, while the corridor, although damaged, remained in place. The walls around the corridor were required to provide 60 minutes' fire protection, and they largely appear to have done so.

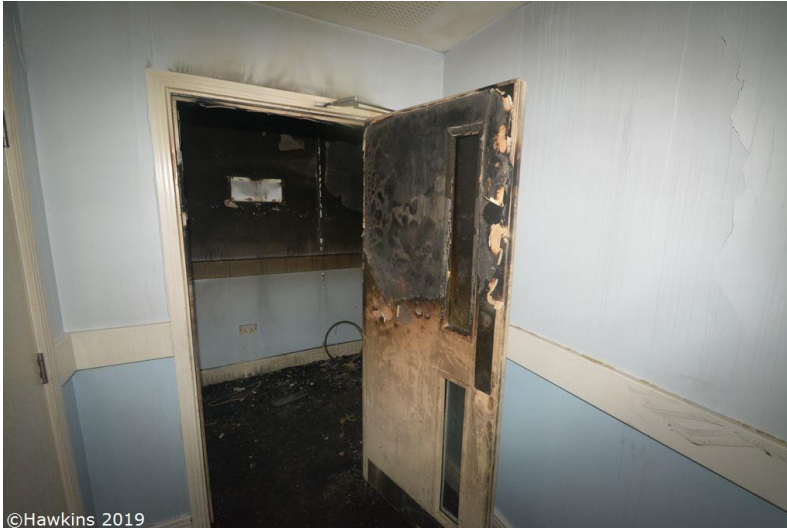
- 2.6 The contrast between the photographs above and below shows the further protection provided by the corridor walls: as noted previously, the photograph above shows the condition within the circulation corridor and the photograph below shows the relatively undamaged condition within the staircase enclosure to the north east of the corridor.

- 2.7 The escape staircase, which was constructed to provide protection for those escaping from the building, remained largely undamaged.

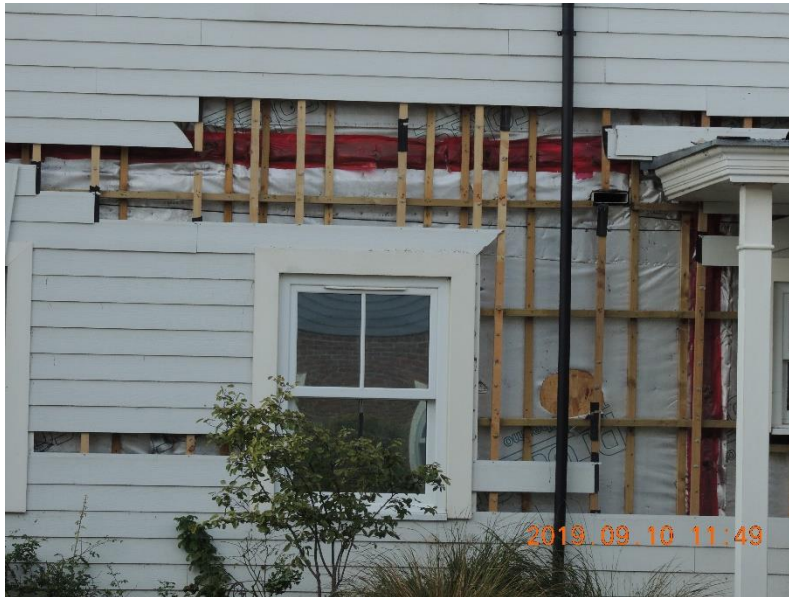
3.3 The Hardie Plank was fixed to three layers of timber battens, of varying thicknesses, which held the Hardie Plank away from the main timber structure. These battens created a void approximately 16cm deep, between the boarding and the main structure, to the full height of the building. The photograph above shows the arrangement of undamaged battens on the north east elevation of the building.

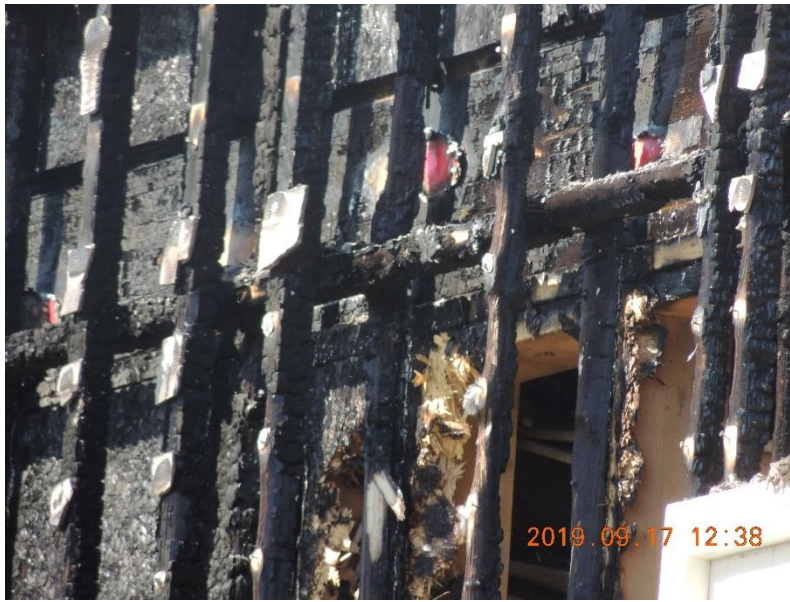
3.4 Once fire entered this void it was able to spread very quickly around the outside of the building as the battens, being natural timber, burned easily. The photograph below shows the condition of the battens when the Hardie Plank boards were broken away during and after the fire.

- 3.5 The spread of fire behind the cladding should have been slowed very substantially by “cavity barriers”, which should have been fitted within the void created by the battens in the following main locations: around all window and door openings in the external wall; on floor lines; and, on party wall lines. Cavity barriers are most often formed of blocks of dense mineral wool insulation, in a polythene sleeve; the patches of red in the photograph above show the remnants of cavity barriers.

- 3.6 For cavity barriers to be effective they have to be compressed in position and to fully close the cavity. Cavity barriers do not completely prevent the spread of fire, but they slow the spread enough that firefighters can tackle it within a limited area. In Richmond House, the cavity barriers that were fitted were defective: they were too small to close the cavity and they would have contributed nothing to control of the fire. Based on the limited number of drawings that I have seen, the defects in the cavity barrier installation appear to be the result of errors in the design.

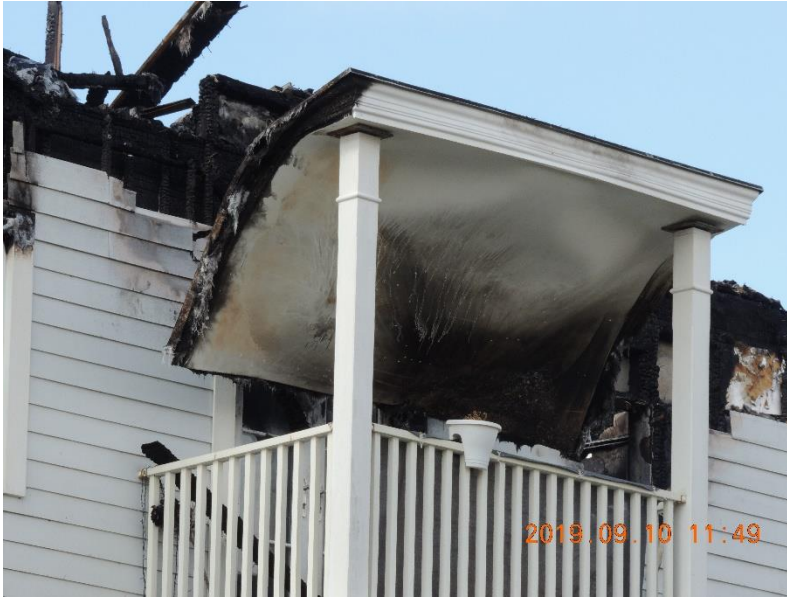
3.7 The balconies had a steel structure, but the framework was finished externally in glass-reinforced plastic ("GRP") and the deck was formed in natural timber. Both GRP and timber burn readily, and both contributed to the development of the fire on the south west elevation. In some places that the fire did not reach, the heat was such that the GRP softened and slumped; the photograph below shows the roof of a balcony on the north east elevation, which collapsed during the fire.

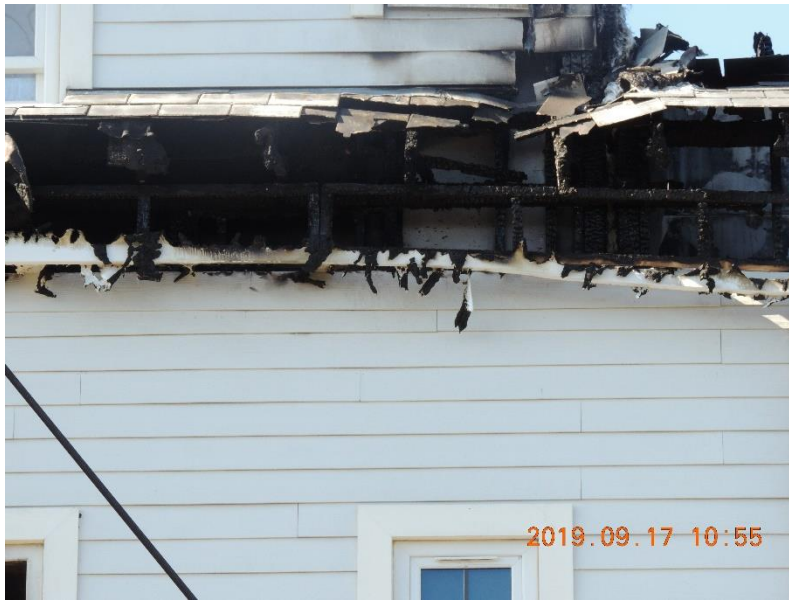
4.2 Fire also spread along the eaves, at the base of the roof. The eaves was boxed in using a dense plastic board, which burned readily and melted away; this board was fixed to timber battens held off the main wall of the building. Cavity barriers should have been installed in the eaves boxing to prevent fire spread, but these were absent.

4.3 The photograph below shows part of the north east elevation, where the remaining charred timber framing at the eaves is visible, the white plastic having almost completely melted away in the fire.
